Appendix B

Identifying asbestos containing materials

Possible situations of asbestos containing materials in DoE facilities

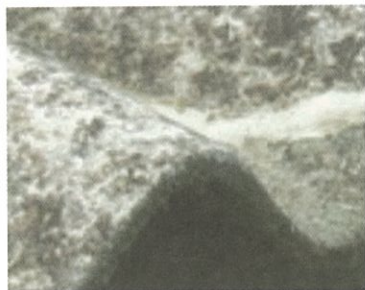
Fibrous cement corrugated roof sheeting panels are very commonly found as roofing on older buildings and occasionally as wall sheeting. Also known as Super Six, these materials typically contain 10-15 per cent asbestos, most commonly chrysotile, although amosite and/or crocidolite have frequently been used. The manufacture of asbestos cement ceased in the late 1980s. A whole of government program removed asbestos cement roofing during the 1980s and early 1990s, however some may remain that was previously unidentified.

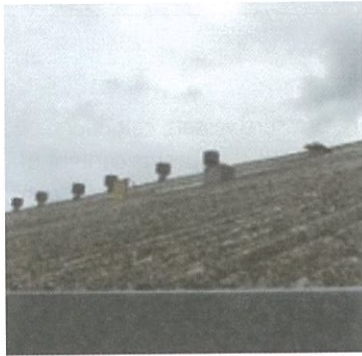
Asbestos cement

The most commonly used asbestos material. Common types include corrugated roof sheeting, flat panel sheeting used for walls and ceilings, as well as flue pipes and insulation boards. Flat fibre cement sheeting has been used extensively in eaves lining, ceilings, and internal and external wall linings. These materials typically contain chrysotile asbestos, although amosite and crocidolite may have been used, particularly in older materials. The asbestos fibres are held in a cement bound matrix, and therefore have a low potential to be released unless abraded or damaged.

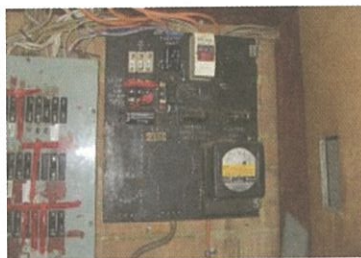
Resinous asbestos insulation board

Typically, these are found as panels behind and/or in front of electric meters and circuits. Chrysotile is the most common asbestos fibre used in these products. The fibres are held in a bonded matrix, and therefore have a low potential to be released unless the material is abraded or damaged.

Electrical insulation board is very commonly found on older electrical meter panels or switch/fuse boards. Sometimes labelled as Zelemite, Lebah or Ausbestos and mostly black in colour. These boards are commonly found as a mounting for electrical meters or as a hinged panel mounting for fuses and switchgear. Typically, chrysotile is bonded into the matrix of the material.

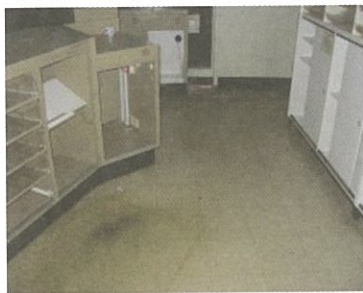
Vinyl floor tiles

Vinyl materials often can have very small quantities of asbestos fibre (typically less than 7%), and are usually of the chrysotile type. Asbestos contained in the vinyl body of the tile or sheet is held in a stable matrix. The very low rate of wear does not normally give rise to the fibre release that is to pose a significant health risk. Asbestos may be found in the vinyl body of the tile or sheet, as a fibrous backing under the tile or sheet and/or as a fibrous adhesive used to fix the tile.

Vinyl floor finishes are very commonly used throughout DoE Facility buildings, usually as small tiles. Sometimes known as Corlon. Generally chrysotile was used as a reinforcing agent between 3-7% for both the vinyl and the reinforced backing of linoleum. Not all vinyl floor tiles contain asbestos and sometimes quantities of asbestos can be too low to detect.

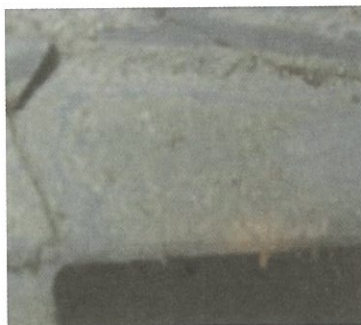
Sprayed asbestos insulation

Sometimes referred to as 'limpet.' Sprayed asbestos was applied as a thermal and anti-condensation insulation material on the underside of roofs as well as a fire protection material on steel and concrete reinforced beams and columns, and on the underside of floors. Over-spray of target areas is common. Spray coatings usually contain 55-85% asbestos with one or a combination of chrysotile, amosite and crocidolite. Generally not applied after the 1970s. Sprays have a high potential for fibre release if unsealed.

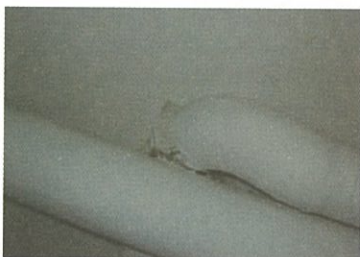
Thermal insulation

Used to insulate pipes, boilers, pressure vessels, calorifiers, etc, and containing between 6 and 85% asbestos content of all types. Often asbestos insulation will be encapsulated with calico and painted, although this type may be easily damaged. Once damage has occurred, the risk of fibre release is high.

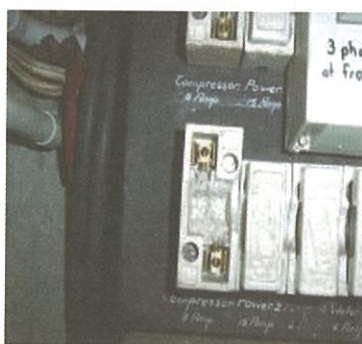
Paper / card and textiles

Paper and card products typically contain chrysotile-type asbestos and can be used for electrical / heat insulation of electrical equipment, wiring and plant as well as a lining for other products. These materials, if not encapsulated or bonded, can easily become damaged and release fibres. Asbestos ropes were often used as heat resistant lagging and seals and electrical flash guards in fuses, typically containing chrysotile and/or crocidolite. Cutting of ropes may increase risk of fibre release, along with degradation over time.

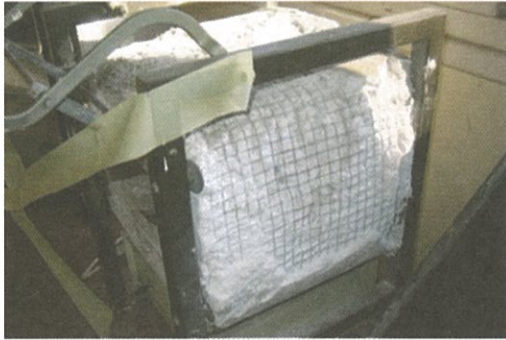
Photograph 01: Kiln with exposed lagging

A small portable plug-in electric kiln used in a secondary school industrial arts area has been found to contain fibrous asbestos lagging. Kilns of this type may have application in secondary school industrial arts, creative arts and possibly science areas and may be present in some primary schools.

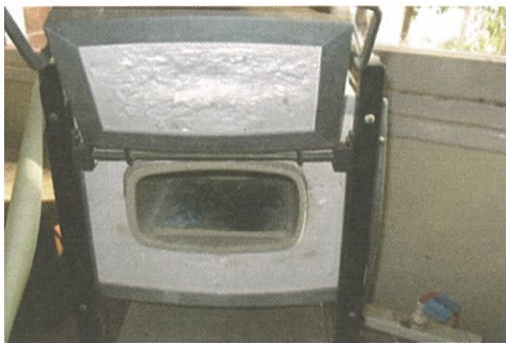
Photograph 02: SMF lagged kiln

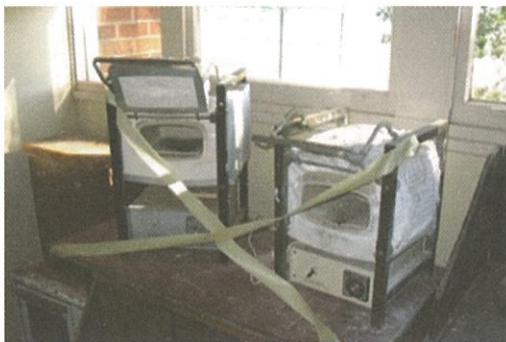
Photograph 03: Two versions of kiln from same manufacturer

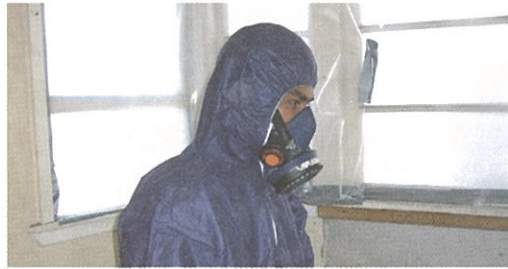
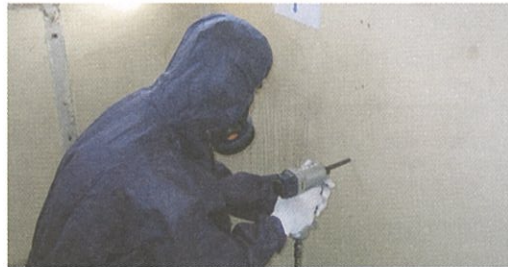
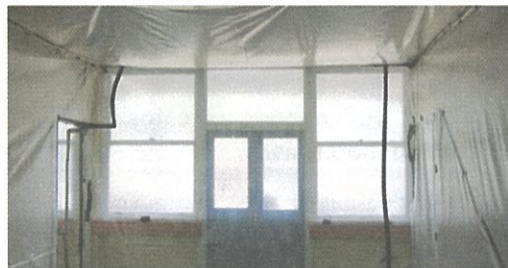
Enclose

DoE may enclose stable asbestos containing material that may be prone to damage but where encapsulating or sealing does not provide sufficient protection or may disturb asbestos fibres.
