9.1 Introduction

9.2.1 Dumping of suspected asbestos waste

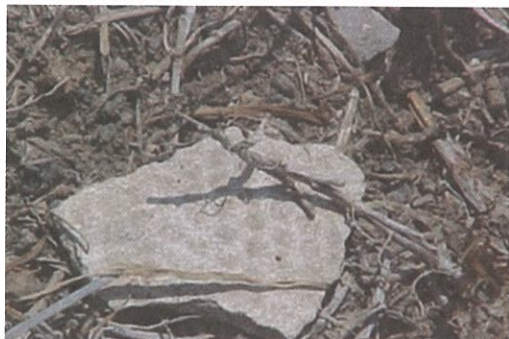
9.2.2 Single source ACM at surface

Suspected single fragment or small number of suspected ACMs observed at a single location.

Fibrous cement sheet debris remaining from builders' waste of recently demolished building / structure.

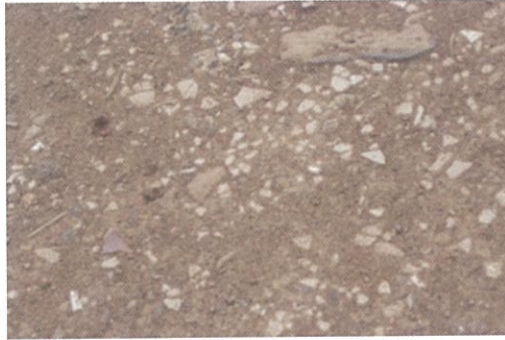
9.2.3 Extensive surface contamination

Numerous fragments of suspected asbestos materials observed over a wide area.

Fibrous cement sheet fragments observed at surface of playing field / school grounds.

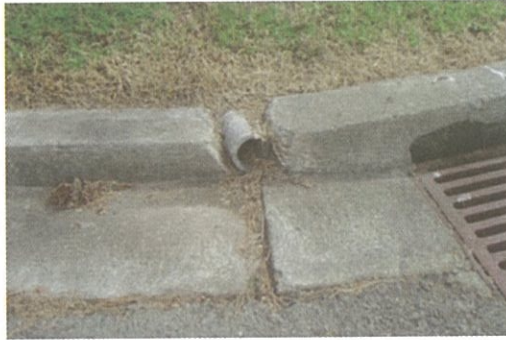
9.2.5 In-ground asbestos cement pipes

Asbestos cement piping is found or suspected to be present within the ground.

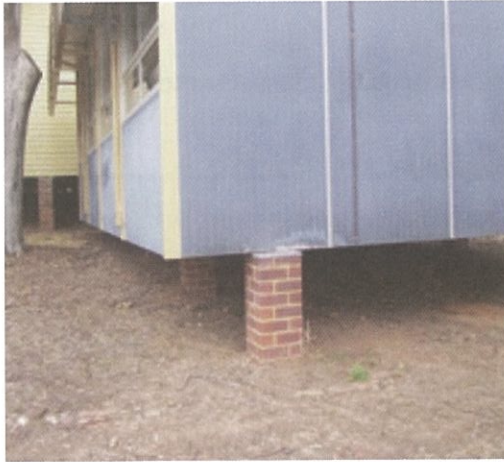
9.3.1 ACMs accessible below buildings

Suspected ACMs observed below a building / facility.

Maintenance work below a demountable classroom has revealed a stack of stored fibrous cement roofing sheeting. Overland flow channelled below a demountable has eroded the surface and revealed fibrous cement materials at the surface.

Asbestos cement packing is suspected within the demountable piers.

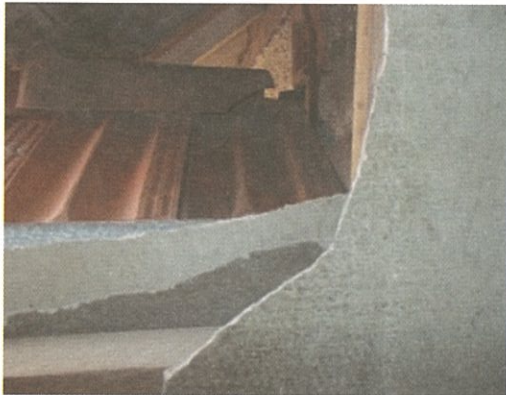
9.3.2 ACM accessible within ceiling or roof space of buildings

ACMs is found or suspected to be present within ceiling / roof cavities.

Maintenance activities have uncovered old asbestos cement sheets. Dust is found to contain asbestos fibres.

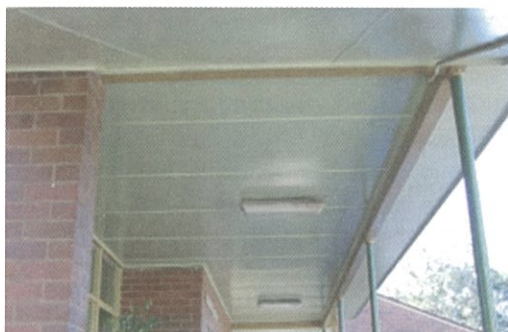
9.3.4 Non-friable ACM in buildings – no damage

ACMs identified or suspected within a building or facility.

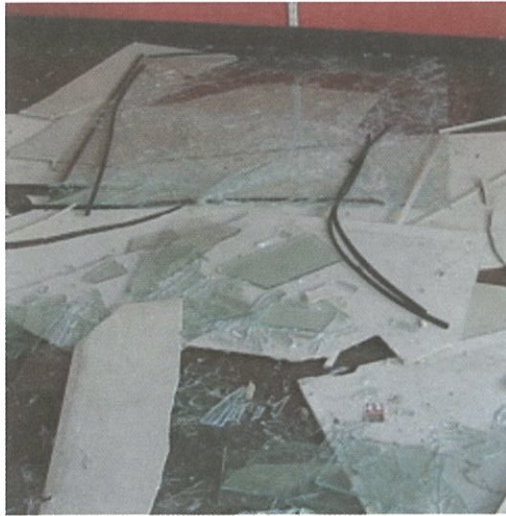
9.3.5 Non-friable ACM in buildings – damaged

Damaged ACMs identified or suspected within a building or facility.

Building inspection has identified a damaged ACMs within a school building.

Asbestos debris found within roof space due to contractors not disposing of waste roof materials.

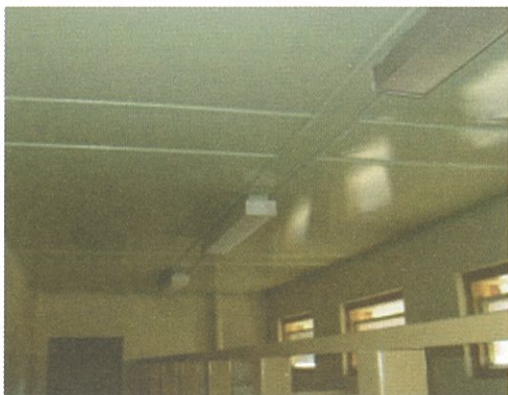
9.3.6 Non-friable ACM to be disturbed by works

Work is required that will disturb an ACMs.

An asbestos workbench requires repair.

Refurbishment requires asbestos walls to be replaced.

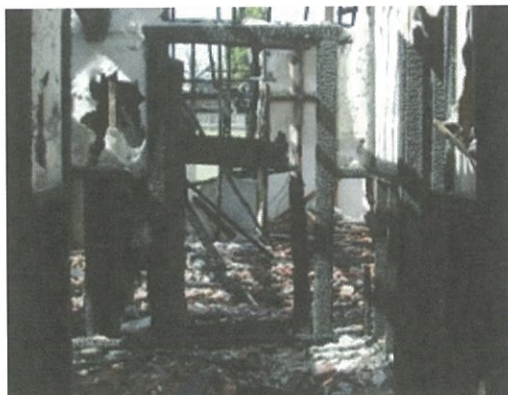
9.3.9 Fire damaged buildings containing ACM

Fire has damaged confirmed or suspected ACMs.

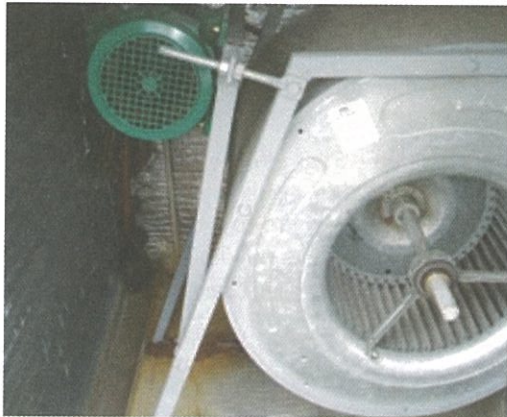
9.3.10 Air handling units containing ACM

Asbestos cement materials used in air-handling units.

Asbestos cement sheet panels lining internal ducting of air-conditioning system.

Asbestos cement sheet panels lining internal ducting of air-movement system.

Asbestos millboard suspected within heater banks of Air handling system.

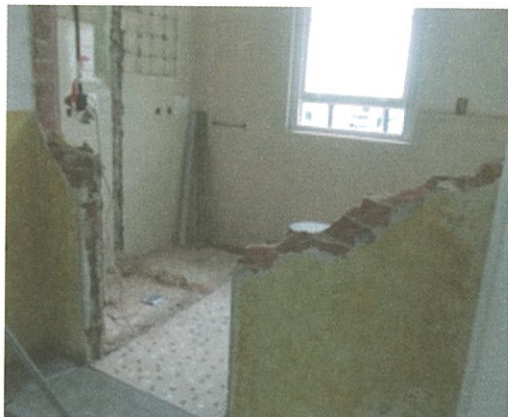
9.3.14 Accidental disturbance of ACM by maintenance / contractor / capital works

Asbestos or suspected ACMs is damaged by contractor or other non-school based person due to maintenance works or general housekeeping.

Work is undertaken before the register is checked and without sampling, resulting in damage to what is later identified to be asbestos containing vinyl wall lining.

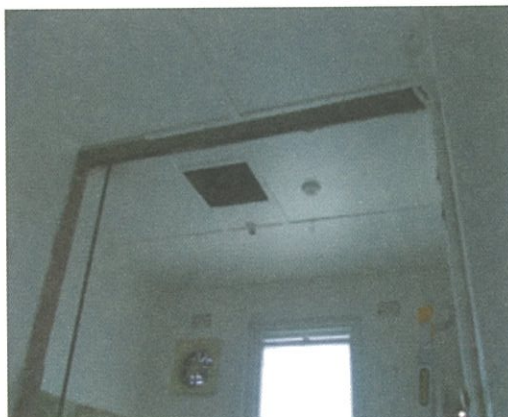
9.3.15 Accidental disturbance of ACM by school based personnel

ACMs or suspected ACMs is disturbed by school based personnel due to maintenance works or general housekeeping.

Work is undertaken around ceiling cavity without prior checking of asbestos register, resulting in disturbance to fibrous cement sheeting.
